Anchor dragging: Master's authority and responsibility

Container loss claims

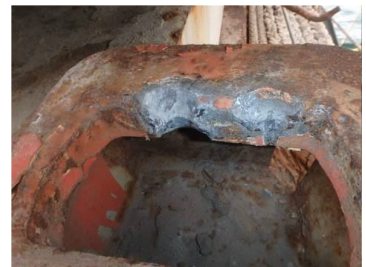
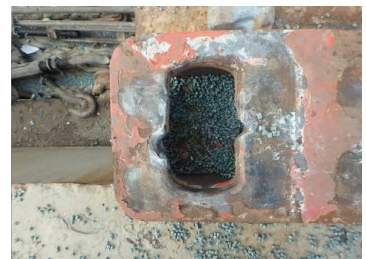
On investigation, a number of container corner castings and container foundations showed no signs of having a locked twist lock forcibly removed during the collapse, the natural conclusion being that the twist locks were in those cases in the unlocked position.

Clear evidence of the forced removal of a 'locked' twist lock

Owners are reminded of the need to ensure that container lashing and securing equipment (including fixed fittings) are included in the ship's planned maintenance system. It is further recommended that at the same time, the ship's equipment is all checked for consistency against the provisions of the ship's prescribed cargo securing equipment inventory within the cargo securing manual.

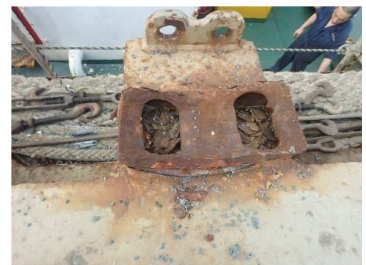
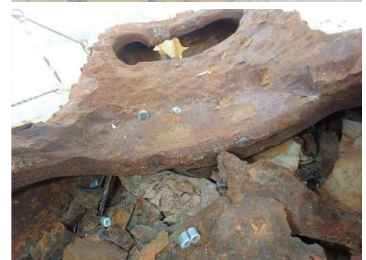
It was also evident that in some cases the degree of wastage of deck/hatch container foundations was such that they were no longer serviceable. As a result, even the best maintained twist lock cannot properly contribute to the planned securing arrangement.

A container foundation's very poor condition makes it unserviceable
