## Chittagong: Outer Anchorage STS operations

## Extract from the Chittagong Port Authority Guidelines for Master's anchoring at Chittagong Outer Anchorage:

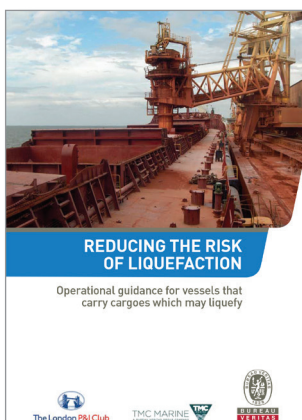
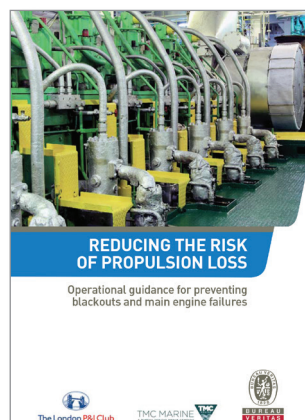
The Club, Bureau Veritas and TMC Marine Consultants have jointly produced these safety management-focused publications

Both publications are available on the Club's website – click [here](#) for *Reducing the Risk of Liquefaction* and [here](#) for *Reducing the Risk of Propulsion Loss*.
